BRIEFING

This company was instructed by Mr [REDACTED] of [REDACTED], to inspect and report on the roofing and cladding for a new [REDACTED], [REDACTED] Retail Park [REDACTED], Haverhill.

A non-intrusive inspection was undertaken on 20 December 2005 for this purpose

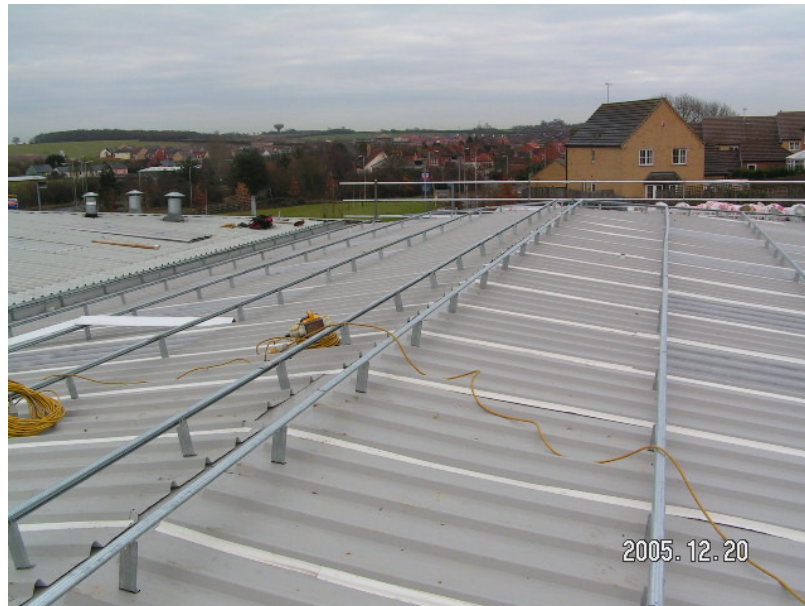
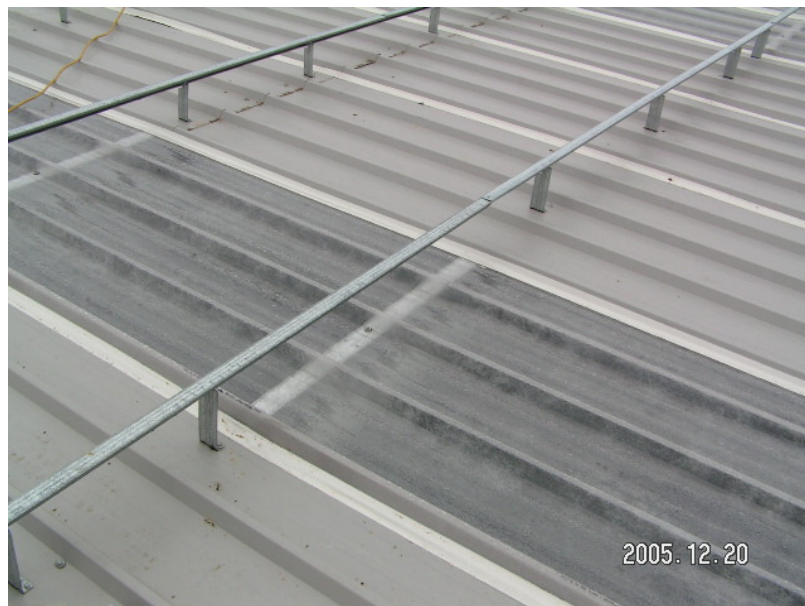
- 1) Some of the ashgrid were facing in the wrong direction. The contractor should satisfy himself that this has no detrimental effect on the roof integrity or compromises the non-fragile status that is being sought.

Similarly the ashgrid spacer was omitted at rooflights. The same request as above applies

The manufacturer's drop test papers should be obtained and the contractor should ensure that compliance is being obtained.

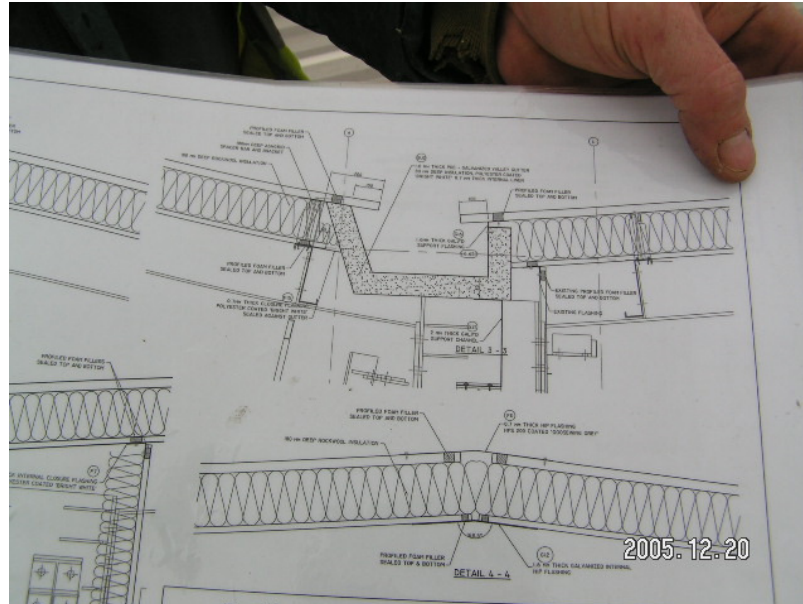
- 2) No anti-sway brackets were observed on the Ashgrid.
- 3) The hip cleaders comprised of a supporting flashing. These were very flimsy and it is doubtful that they would survive a drop test. The contractor should be requested to prove this method of support, or install suitable structural cleaders.
- 4) The valley gutter adjoining the existing building had been installed and to a different detail to the drawings issued to us prior to our arrival on site, copy shown below.
